# Property Inspection Report

*911 Krypton Blvd  
Metropolis, TX 78888*

1/1/2024 9:00 AM

Inspection Report Prepared For:  
Clark Kent

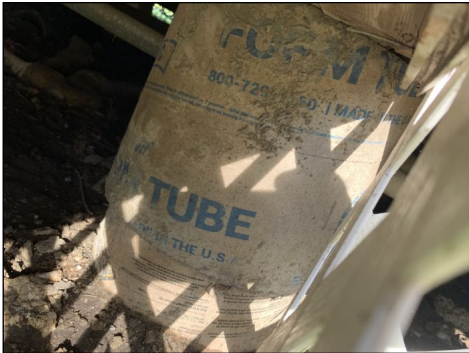
Some of the piers installed in the crawlspace to support the home foundation still had the paper/cardboard forms adhered to the piers. Removal of the paper/cardboard from the foundation piers is generally recommended to help prevent potential moisture retention issues and pest intrusion.

Paper/cardboard on foundation pier

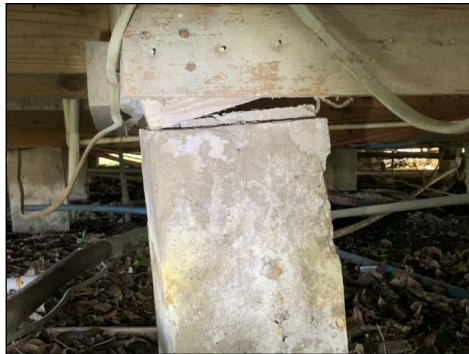
Some beams observed in the crawlspace were not adequately resting on piers/blocks for proper foundation support and some piers were damaged/leaning.

Piers/blocks damaged/leaning inadequately supporting

Further evaluation is recommended by a qualified foundation contractor and/or structural engineer as to the present and future performance of the foundation and any repairs.

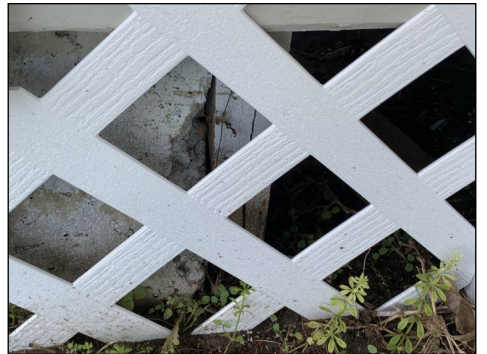
Damaged foundation pier/block

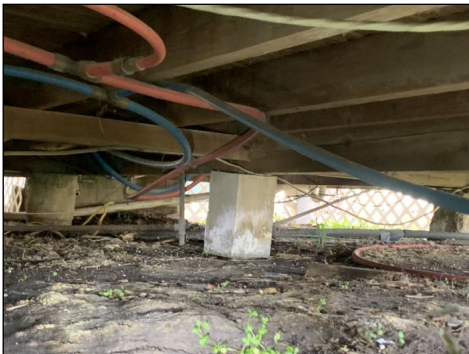
Pier/block leaning

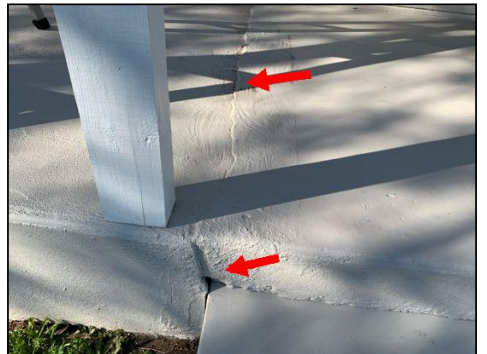
The front porch slab was cracking in some areas.

Front porch slab cracking

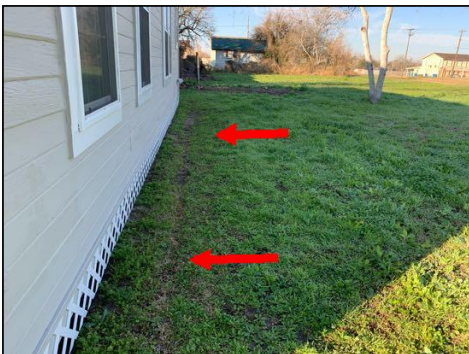
Negative site drainage was observed at several sides of the home. Grade around the home should be sloped correctly to properly control the run off of storm water. A slope of 6" in 10' away from the foundation perimeter is recommended for proper drainage necessary to help prevent water from standing and/or ponding next to the foundation area or running into a crawl space.

*Grade slopes toward the crawlspace at the right side of the home*

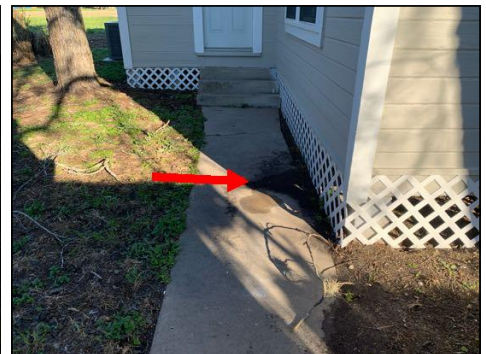
*Grade slopes toward the crawlspace at the back of the home*

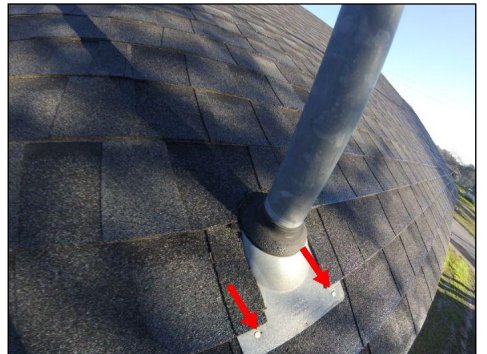
Exposed fastener heads were noted at some roof penetration flashings. Sealing of exposed fasteners with a proper roofing sealant is recommended to help prevent rust and moisture penetration.

*Exposed fasteners at roof flashing*

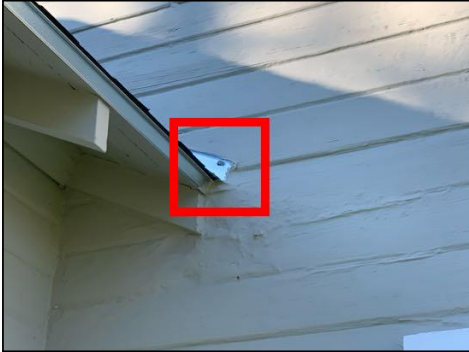
Kick out flashing/diverter flashing was not installed at one or more areas where the exterior walls and the roof meet around the home exterior. The installation of kickout flashing/diverter flashing is recommended to help direct the flow of storm water away from the exterior wall(s) of the home.

No kick out/diverter flashing at the front of the home

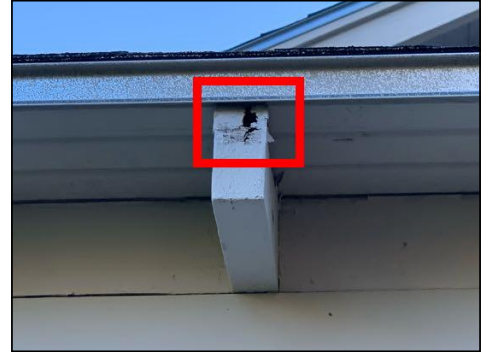
The exposed roof structure/roof deck had some areas of decay/rot at the home exterior that should be repaired to help maintain the structural integrity of the roof structure.

Exposed roof structure (rafter tails) decay/rot at the back of the home

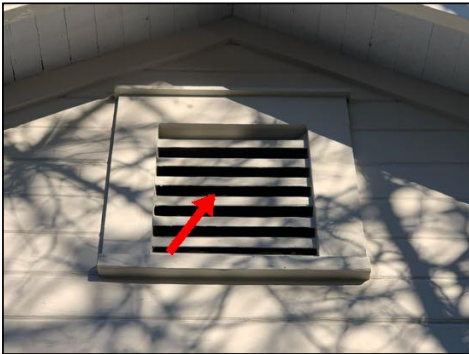
The screen was found to be damaged/missing in one or more of the exterior gable vents. Repair is recommended to help prevent pest intrusion into the attic space.

Gable vent screen damaged/missing at the left side of the home

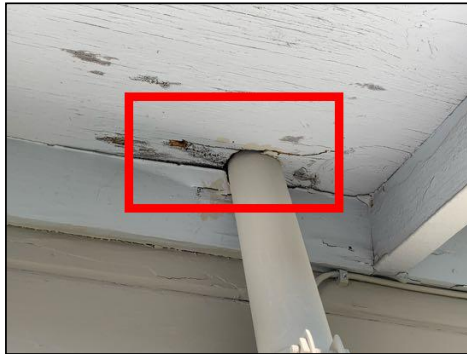
Exposed roof deck decay/rot at the left side of the home

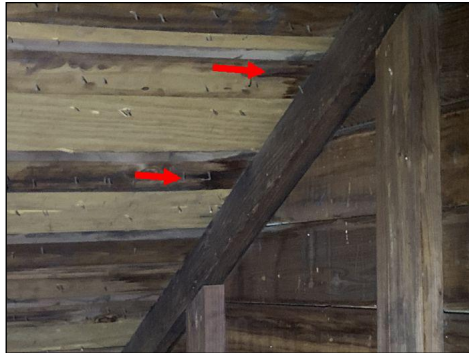
Moisture staining was visible on the roof deck/roof structure in the attic space. The moisture staining was not accessible to touch to determine moisture content and may be attributed to previous roof covering material deficiencies. Further evaluation for any active moisture intrusion and repair recommendations should be conducted by a qualified roofing contractor.

*Moisture stains on roof structure in attic space*

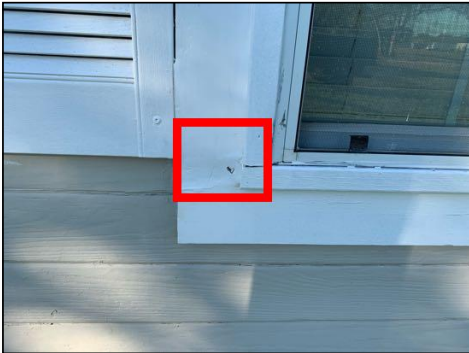
Wood trim decay/rot at the front of the home

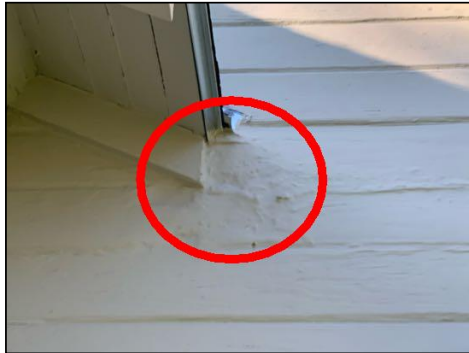
Wood siding decay/rot at the front of the home

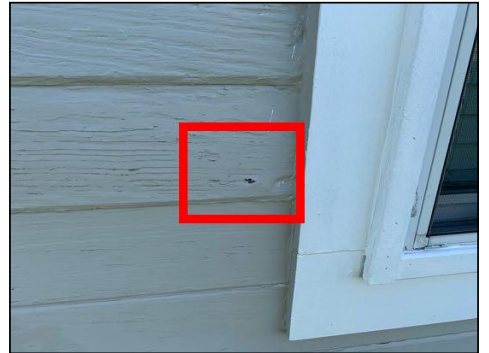
Wood siding decay/rot at the right side of the home

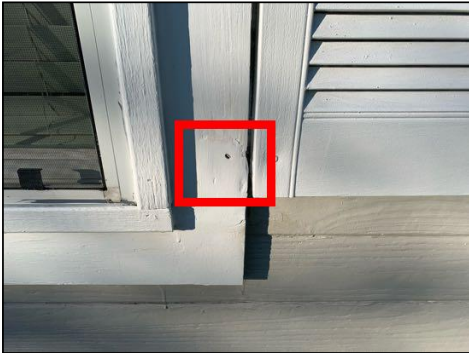
Wood trim decay/rot at the front of the home

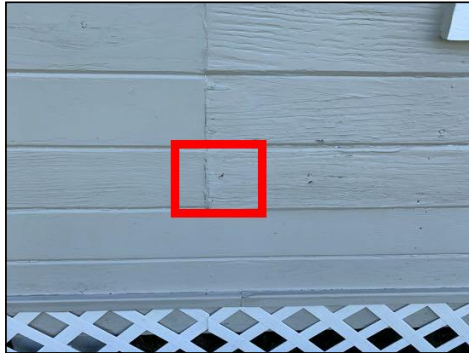
Wood siding decay/rot at the right side of the home

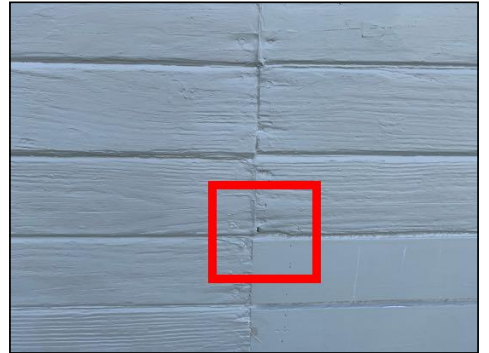
Wood siding decay/rot at the right side of the home

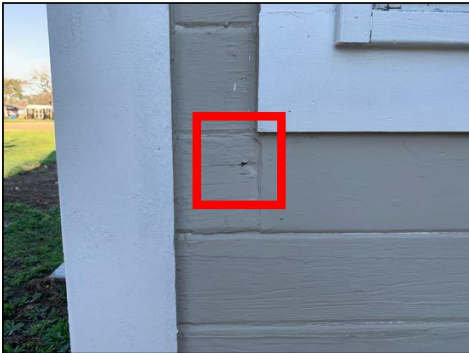
Wood siding decay/rot at the back of the home

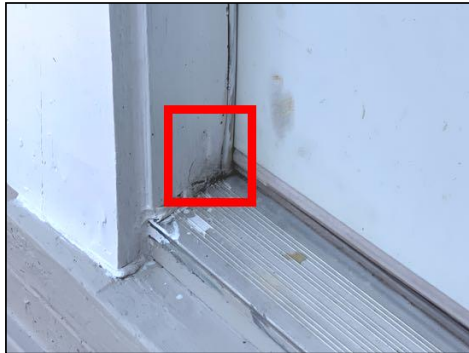
Wood trim decay/rot at the back of the home

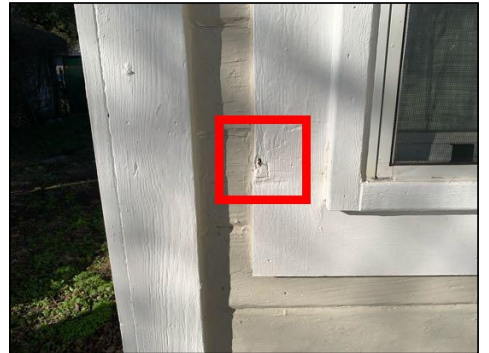
Wood trim decay/rot at the left side of the home

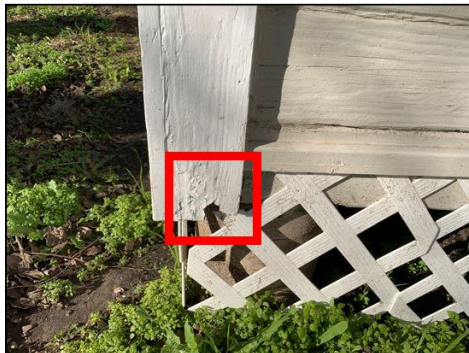
Wood trim decay/rot at the left side of the home

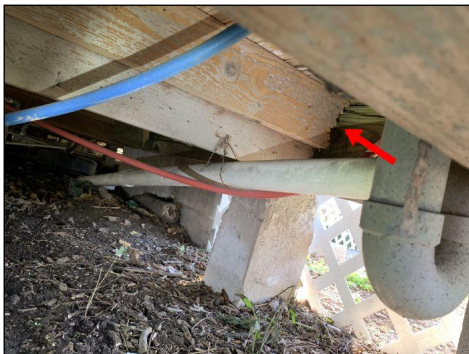
Floor joist decay/rot below laundry room

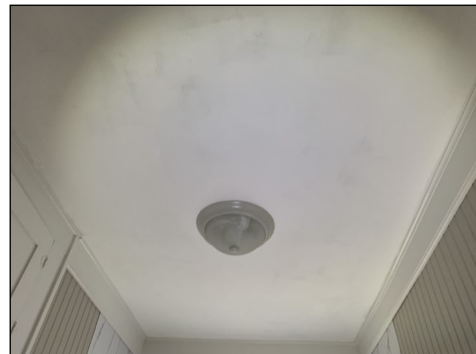
A black colored microbial growth was visible on the interior ceiling drywall in the hall bathroom that had been covered with paint possibly attributed to roof leaking from deficiencies in previous roof covering materials. Further evaluation is recommended by a qualified environmental company for repairs and cleaning of the black microbial growth.

Black microbial growth on hall bathroom ceiling

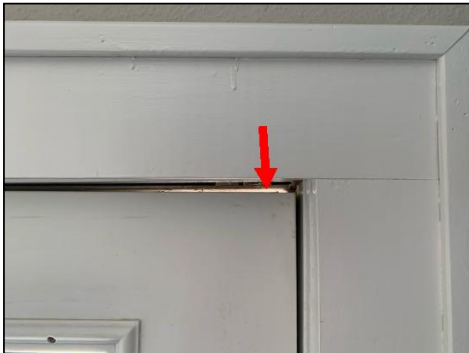
The front exterior door and the back exterior door failed to seal closed properly and did not appear to be adequately weather sealed. Repair/installation of the weatherstrip and/or threshold for proper seal is recommended.

Front exterior door failed to seal closed properly

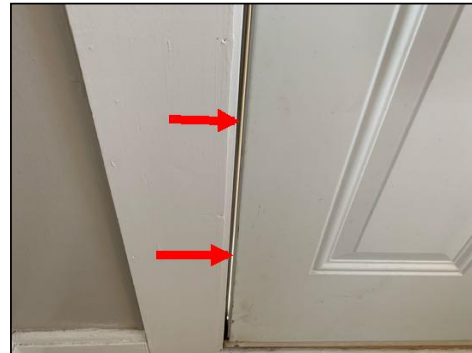
Back exterior door failed to seal closed properly

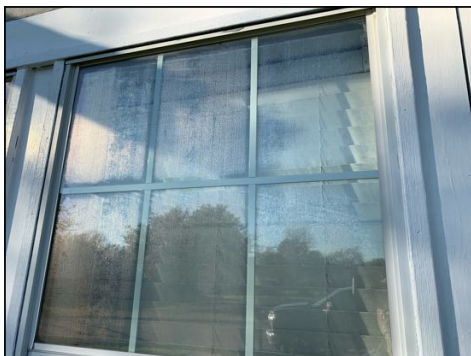
*Living room window fogged*

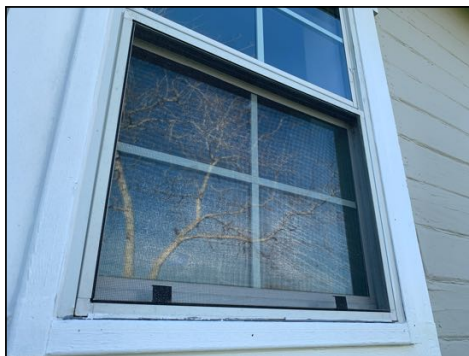
*Kitchen window fogged*

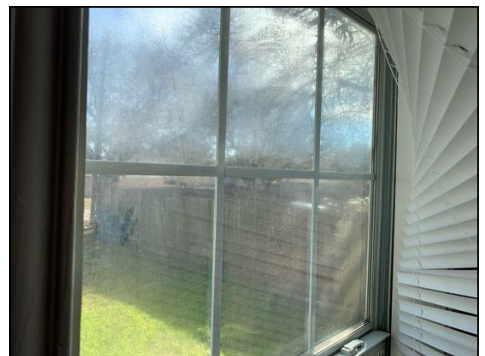
*Back left bedroom window fogged*

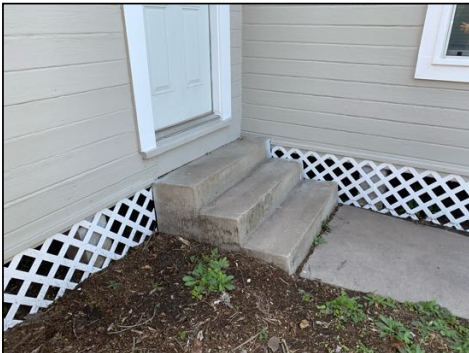
Back exterior steps not level/No handrail installed

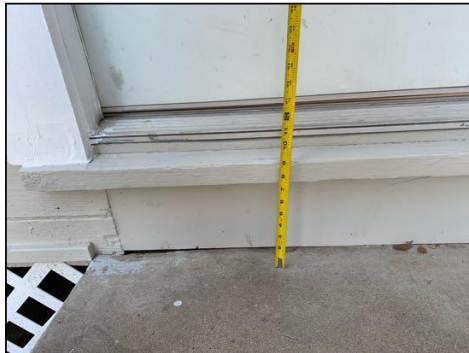
The back exterior steps (top step) height exceeded 7 3/4 inches. Current standards recommend that stair/step height not exceed 7 3/4 inches. (Trip Hazard)

Top step to door threshold exceeded 7 3/4 inches in height

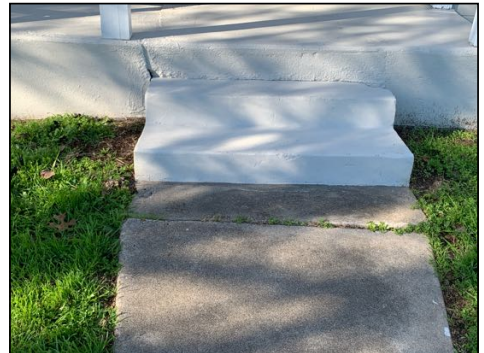
The front exterior steps were not installed level. (Trip Hazard)

Front exterior steps not level

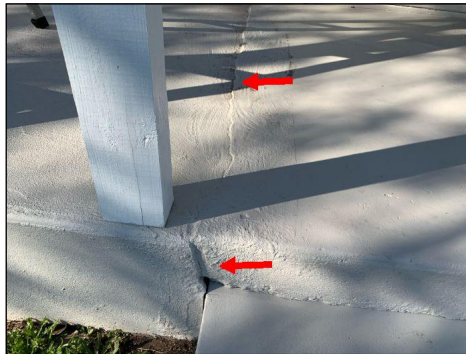
The front porch slab was cracking in some areas.

*Front porch slab cracking*

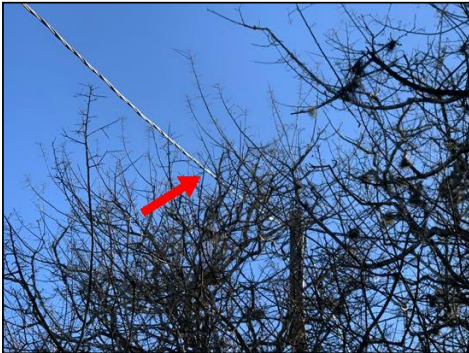
*Overhead electrical service inadequate tree clearance*

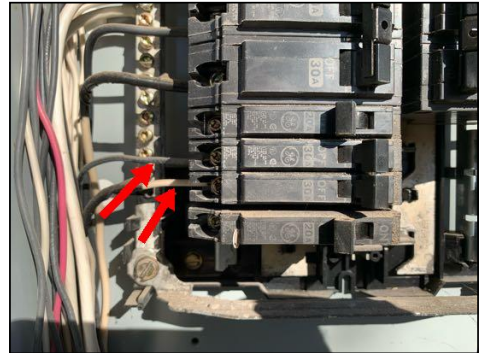
*Improper size conductors in 30amp breaker*

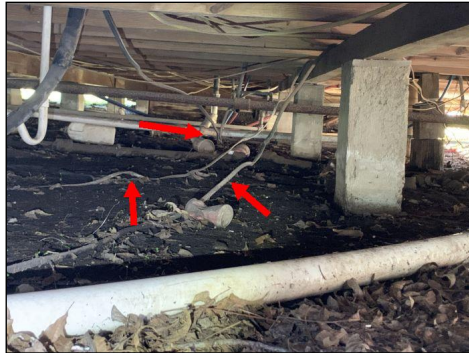
Unsecured electrical wiring was visible in the crawlspace beneath the home. Securing the electrical wiring from ground contact is recommended by a licensed electrician.

*Unsecured electrical wiring in crawlspace beneath the home*

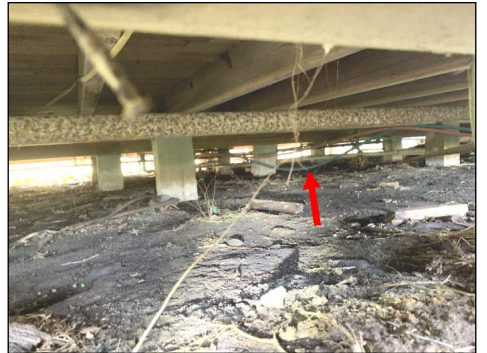
*PEX Water supply plumbing in crawlspace not secured/strapped*

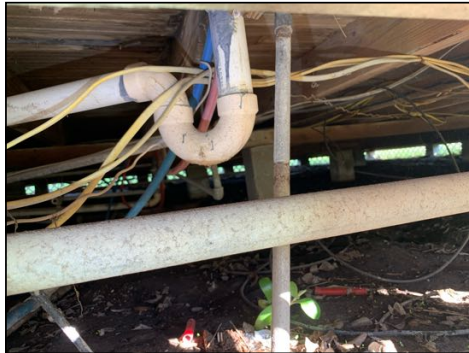
Drain plumbing leaking beneath the home/bathroom

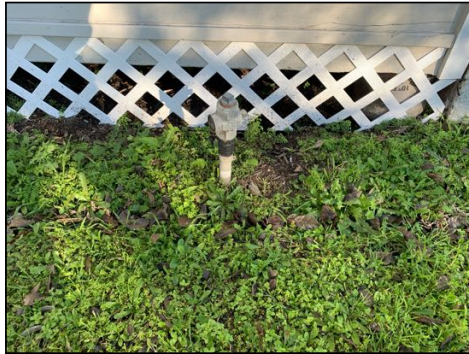
No natural gas meter was installed at the left side exterior where provisions were present for natural gas.

No natural gas meter installed at left side exterior

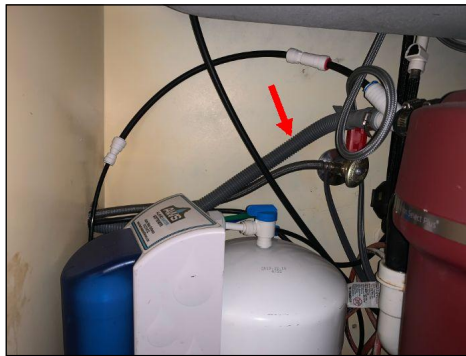
The dishwasher drain did not have a secured loop installed in the drain plumbing. (Backflow prevention high loop). The installation of a secured loop (high loop) in the dishwasher drain plumbing is recommended to help prevent backflow.

*No high loop installed in the dishwasher drain for backflow prevention*

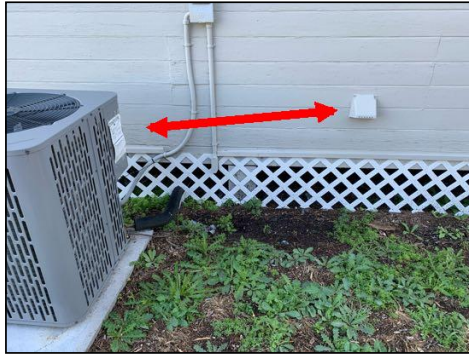
The dryer vent termination discharged in close proximity to the exterior condensing unit. The efficiency of the condensing unit may be compromised with the venting of hot air from the dryer appliance and any dryer lint may block air flow at the condensing unit. It is recommended that the dryer vent terminate a minimum of ten feet from the condensing unit and a minimum of three feet from building openings.

*Dryer vent termination too close to back exterior condensing unit*
