# Property Inspection Report

*911 Krypton Blvd  
Metropolis, TX 78888*

1/1/2024 9:00 AM

Inspection Report Prepared For:  
Clark Kent

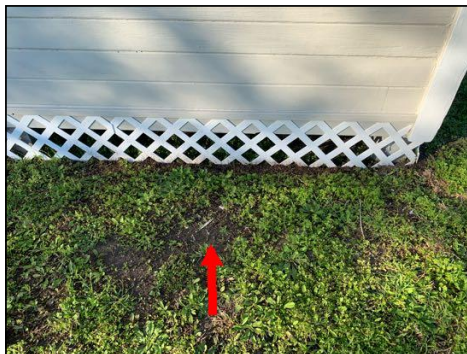
*Grade slopes toward the crawlspace at the front of the home*

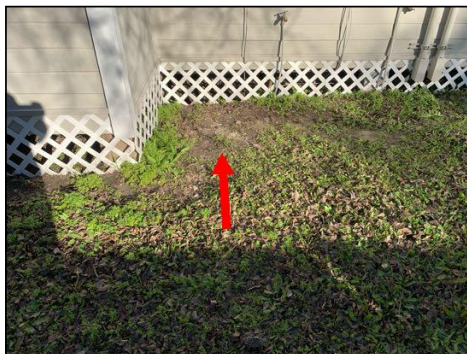
*Grade slopes toward the crawlspace at the left side of the home*

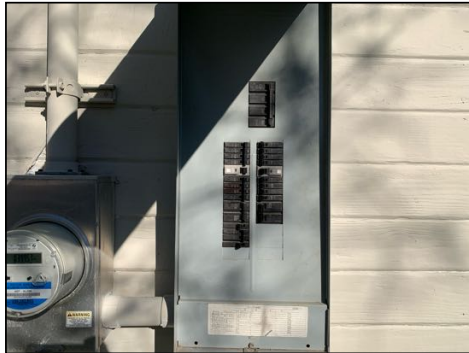
*Main panel at left side exterior*

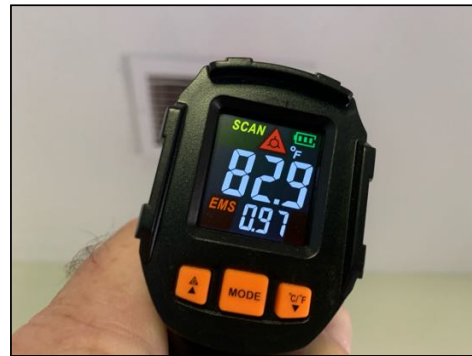
The heating equipment was operated at the thermostat and warmed the home interior to approximately 82 degrees. No operating/heating deficiencies were observed at the time of the inspection.

Warmed heating equipment to 82 degrees

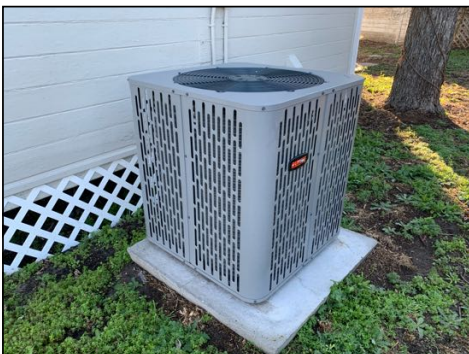
The exterior condensing unit was unsecured. Strapping/securing the exterior condensing unit is recommended to help prevent damage to the unit and/or the refrigerant lines.

Trane condensing unit at back exterior

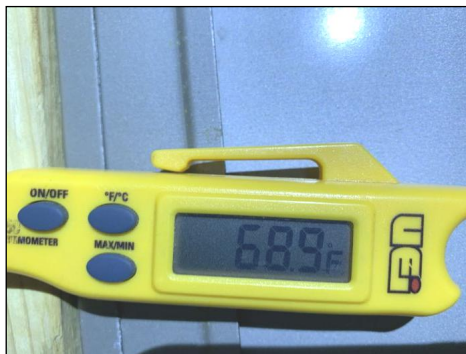
The temperature differential range of the return and supply air during normal operation of the central cooling equipment between 15 to 22 degrees would indicate adequate performance of the equipment. The home cooling equipment was operated at the thermostat and the temperature differential of the cooling equipment at the time of the inspection was found to be 19 degrees.

Return Air temperature

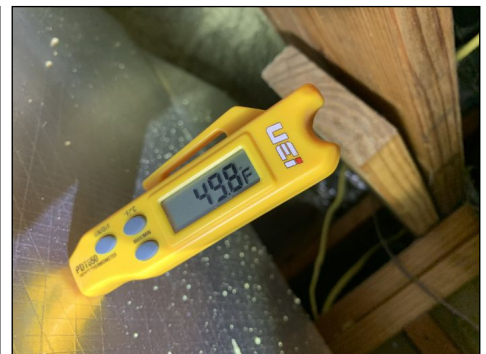
Supply Air temperature

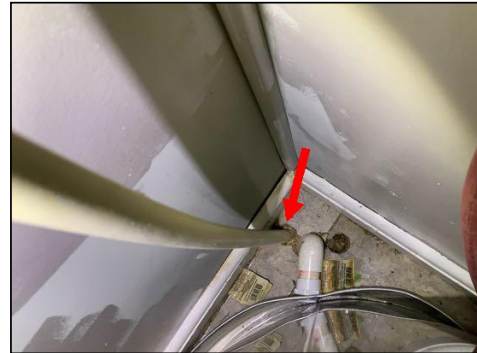
TPR valve discharge plumbed below the home
