# Property Inspection Report

*911 Krypton Blvd  
Metropolis, TX 78888*

1/1/2024 9:00 AM

Inspection Report Prepared For:  
Clark Kent

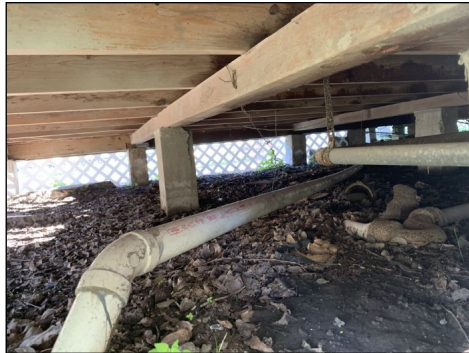
Crawlspace view

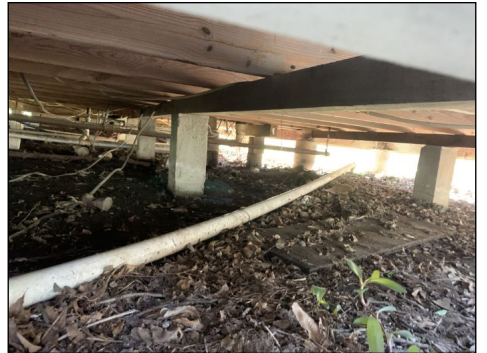
Crawlspace view

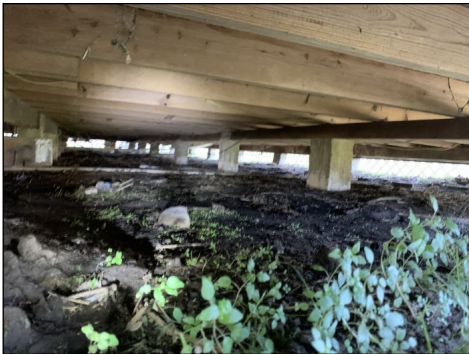
Crawlspace view

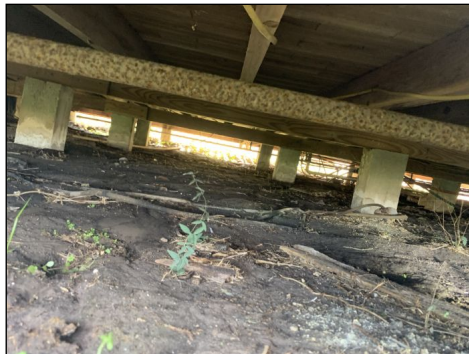
Crawlspace view

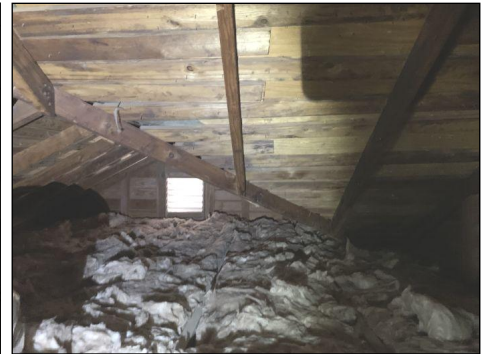
Attic view

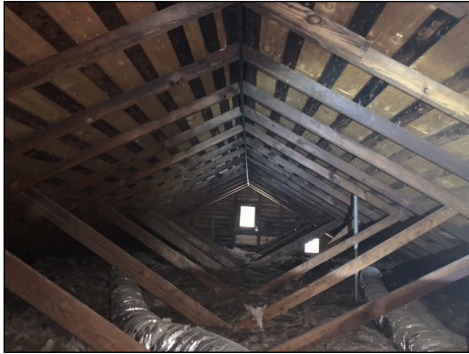
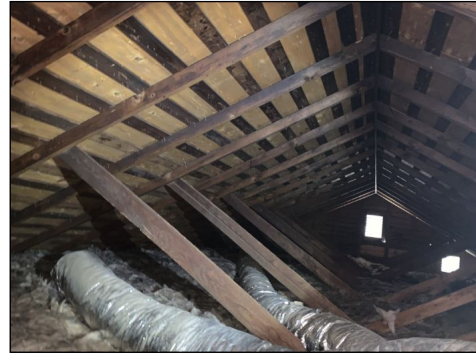
Visible and accessible duct work in the attic space and the interior air registers appeared to be performing the intended function at the time of the inspection.

*Attic ducts*

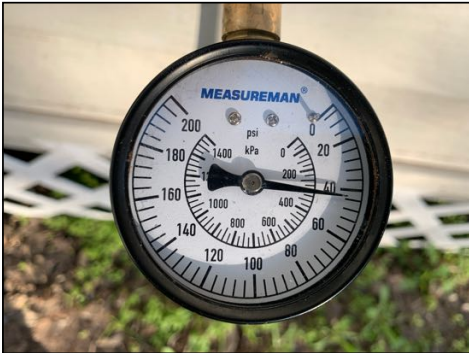
*Water pressure 45 psi*

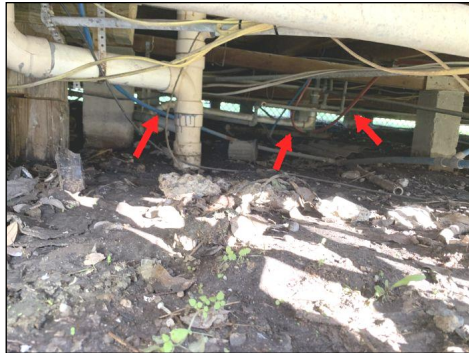
*PEX Water supply plumbing in crawlspace not secured/strapped*
